Addendum to Agenda for Chevron CAP meeting June 24, 2010**Area 2 Seepage: Questions received from Judi Marshall & David McLellan****1. When was the leak/spill first detected?**

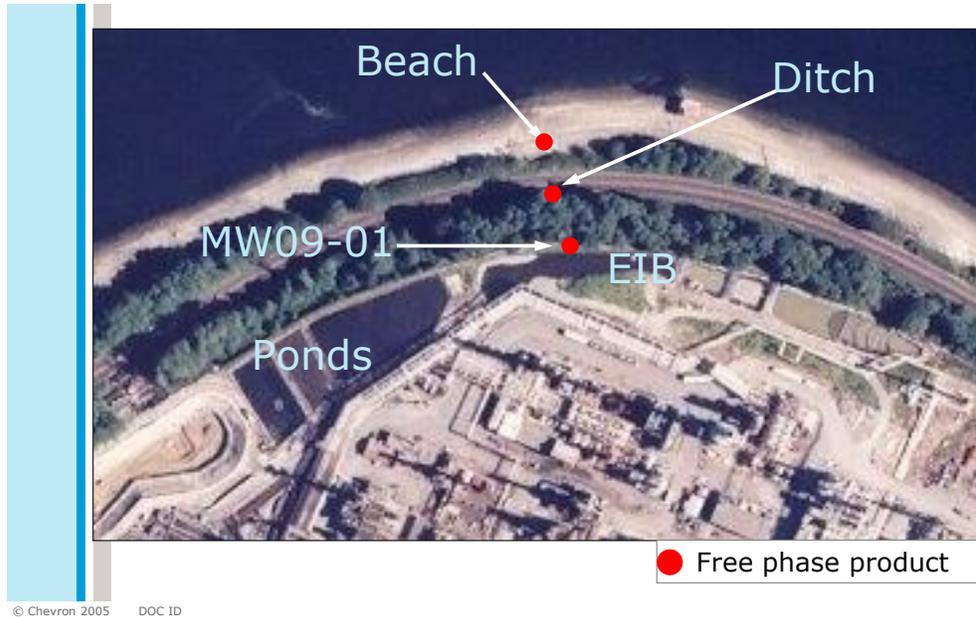
Area 2 Location

9. Is there a visual overview of how much of the area is affected?
